Deutsche Luftfahrtforschung

Examinations and Notices No. 562

Report about strength examinations on an outer wing of the russian airplane type Rata I16 Krumbholz

drafted by Deutsche Versuchsanstalt für Luftfahrt E.V. Institut für Festigkeit Berlin-Adlershof

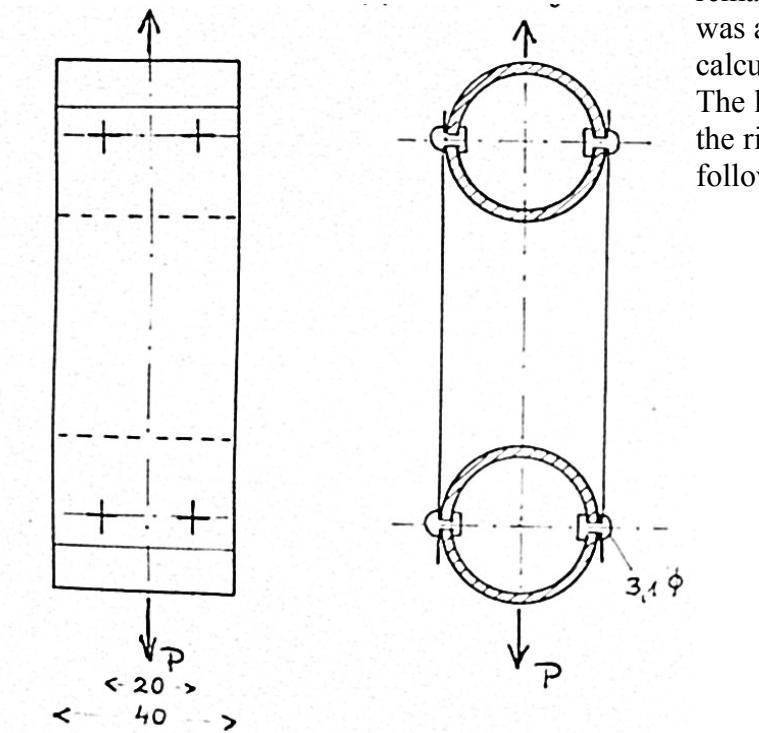
In a third test series the shear strength of the riveting of the web (Dural) was examined. Out of a part of the front spar 4 40mm wide Strips were cut out (sketch), in a way that 2 adjacent rivets

remained. The force vector of the force P was arranged, that all rivets (by calculation) would carry the same load. The load P was increased until failure of the riveted connection. The 4 tests had the following result:

Sample	Break load P _{BR} kg	Rivet – dia d mm ⁺⁾	Shear cross section F = 4 Pi $d^{2}_{/4}$ mm ²	Shear strength P_{BR} / F kg/mm ²	comment
1	710	3,1	30,2	23,5	In each test
2	820	3,1	30,2	27,2	each time 2
3	678	3,1	30,2	22,5	sheared off
4	760	3,1	30,2	25,2	simultaneously
Average	742		30,2	24,6

The average shear strength is $tau = 24,6 \text{ kg/mm}^2$ and is only slightly below that value for domestic rivets:

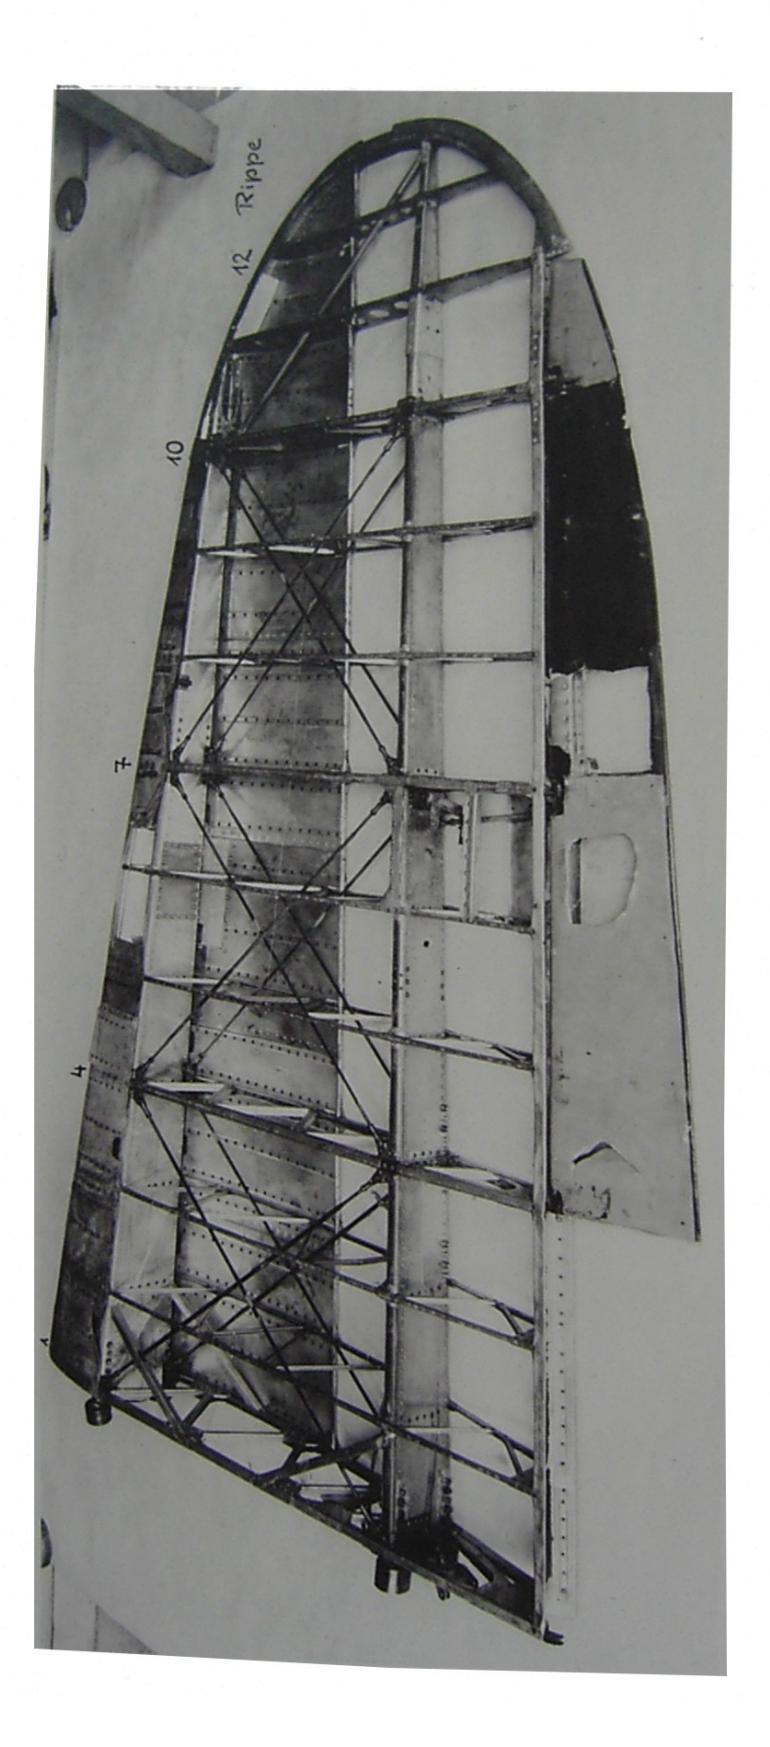
<u>Abb. 2</u> Linker Außenflügel. Ansicht schräg von unten. Zustand nach dem Bruchversuch. :

photo detail pg 21

A left hand outer wing (photo pic.2) and fragments of a spar of another outer wing were provided by the E-Stelle Rechlin (Testing grounds Rechlin). The outer wing has 2 spars and is connected to the inner wing by 4 sperical contact joints (pic.3; also schematic drawing of the sample in pic.1). The spars are constructed of drawn steel tubing spar caps and Dural- plain sheeting, riveted together. Pic.4a and b show the most important dimensions in graphical composition. To establish the cross sections of the spar caps, the spar caps were cut apart in several positions, after the test to destruction. The spar caps have one joint each: The front spar between ribs 7 and 8, the rear spar between 5 and 6. In between the sperical contact joints and the joints the outer surface of the caps is turned down conically over a long distance. Outerboard of the joints the spar caps have lightening slots, pointing towards each other. In the outer part of the wing – outboard of rib 10 – the spars are made from a Dural C-shape.

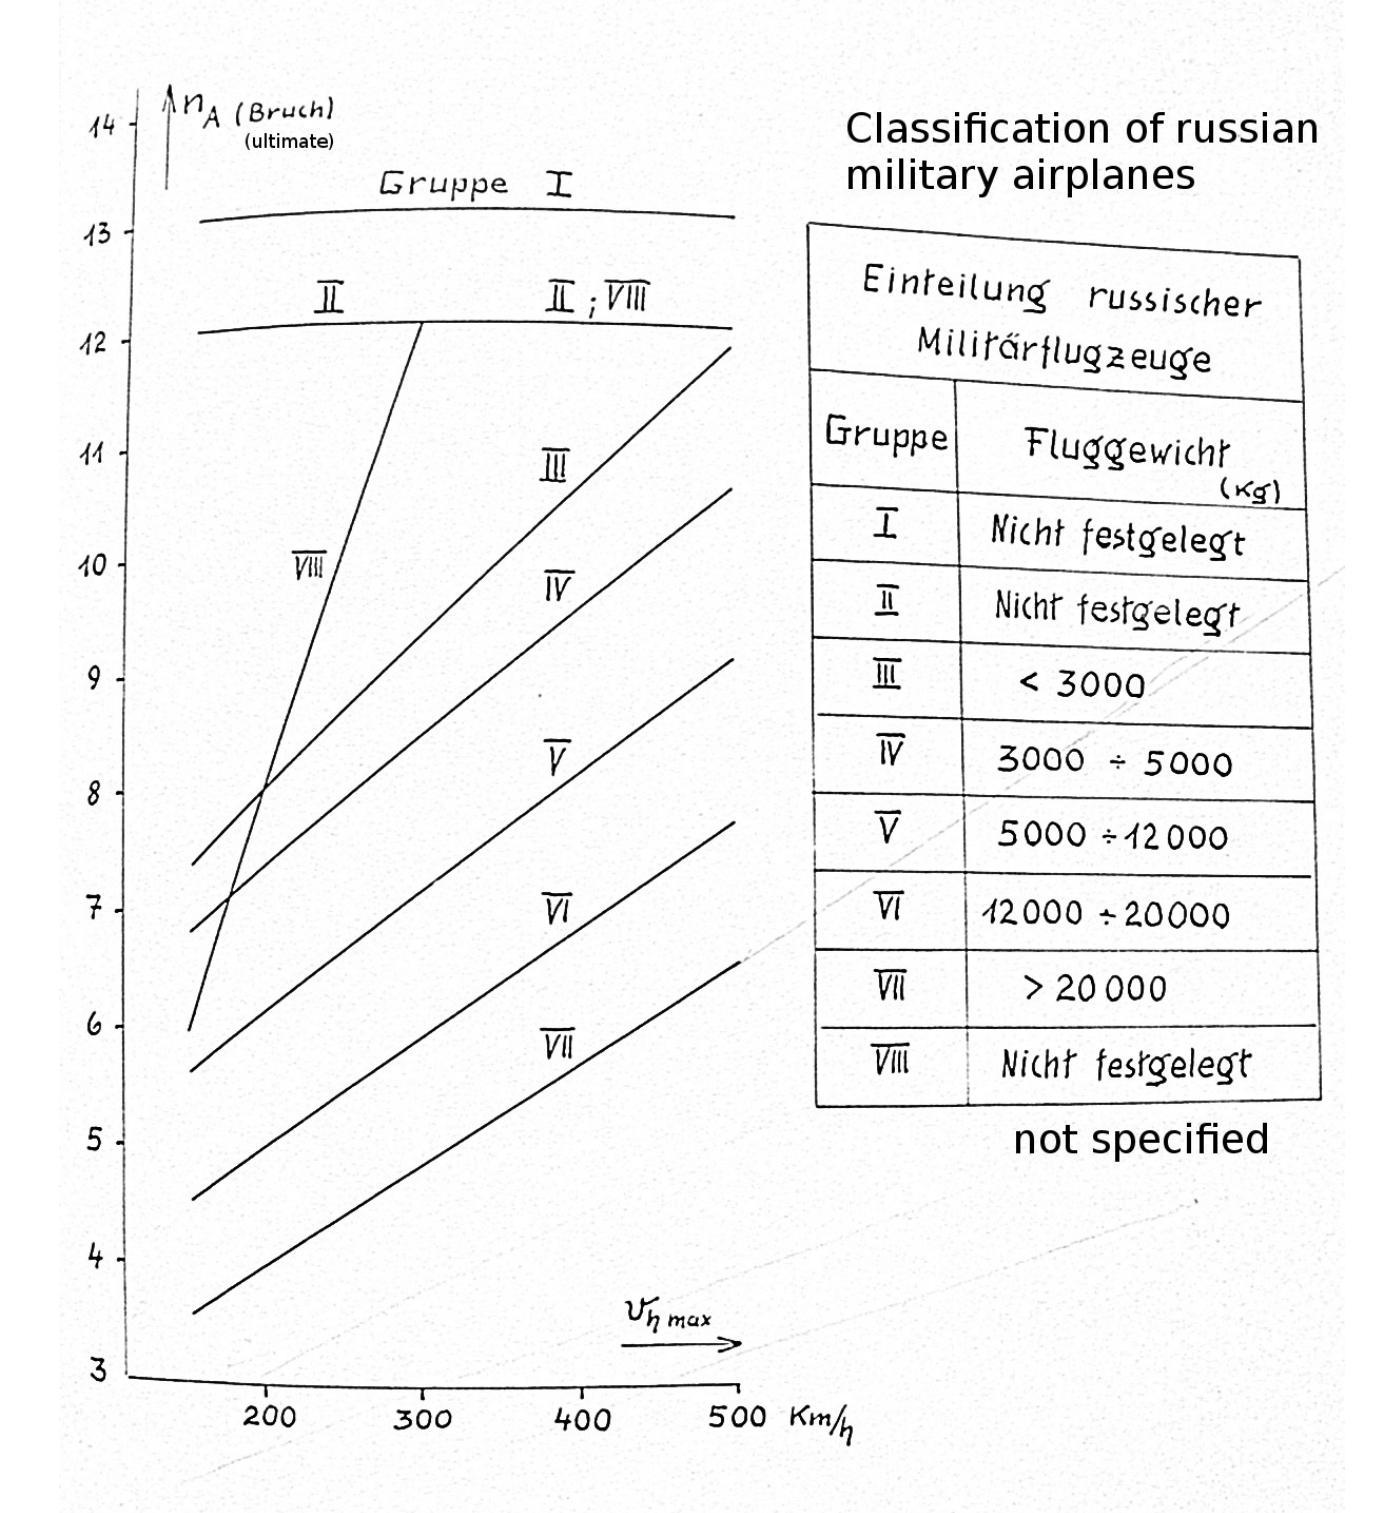
Pic. 5 Classification of russian military airplanes. Correlation of the load factor n ('Pull up') from the group and the maximum

<u>Abb. 5</u> Horizontal Speed. Gruppeneinteilung der russischen Militärflugzeuge. Abhängigkeit des Bruchlastvielfachen n_A (Abfangen) Von der Gruppe und der größten Wangerechtgeschwindigkeit.

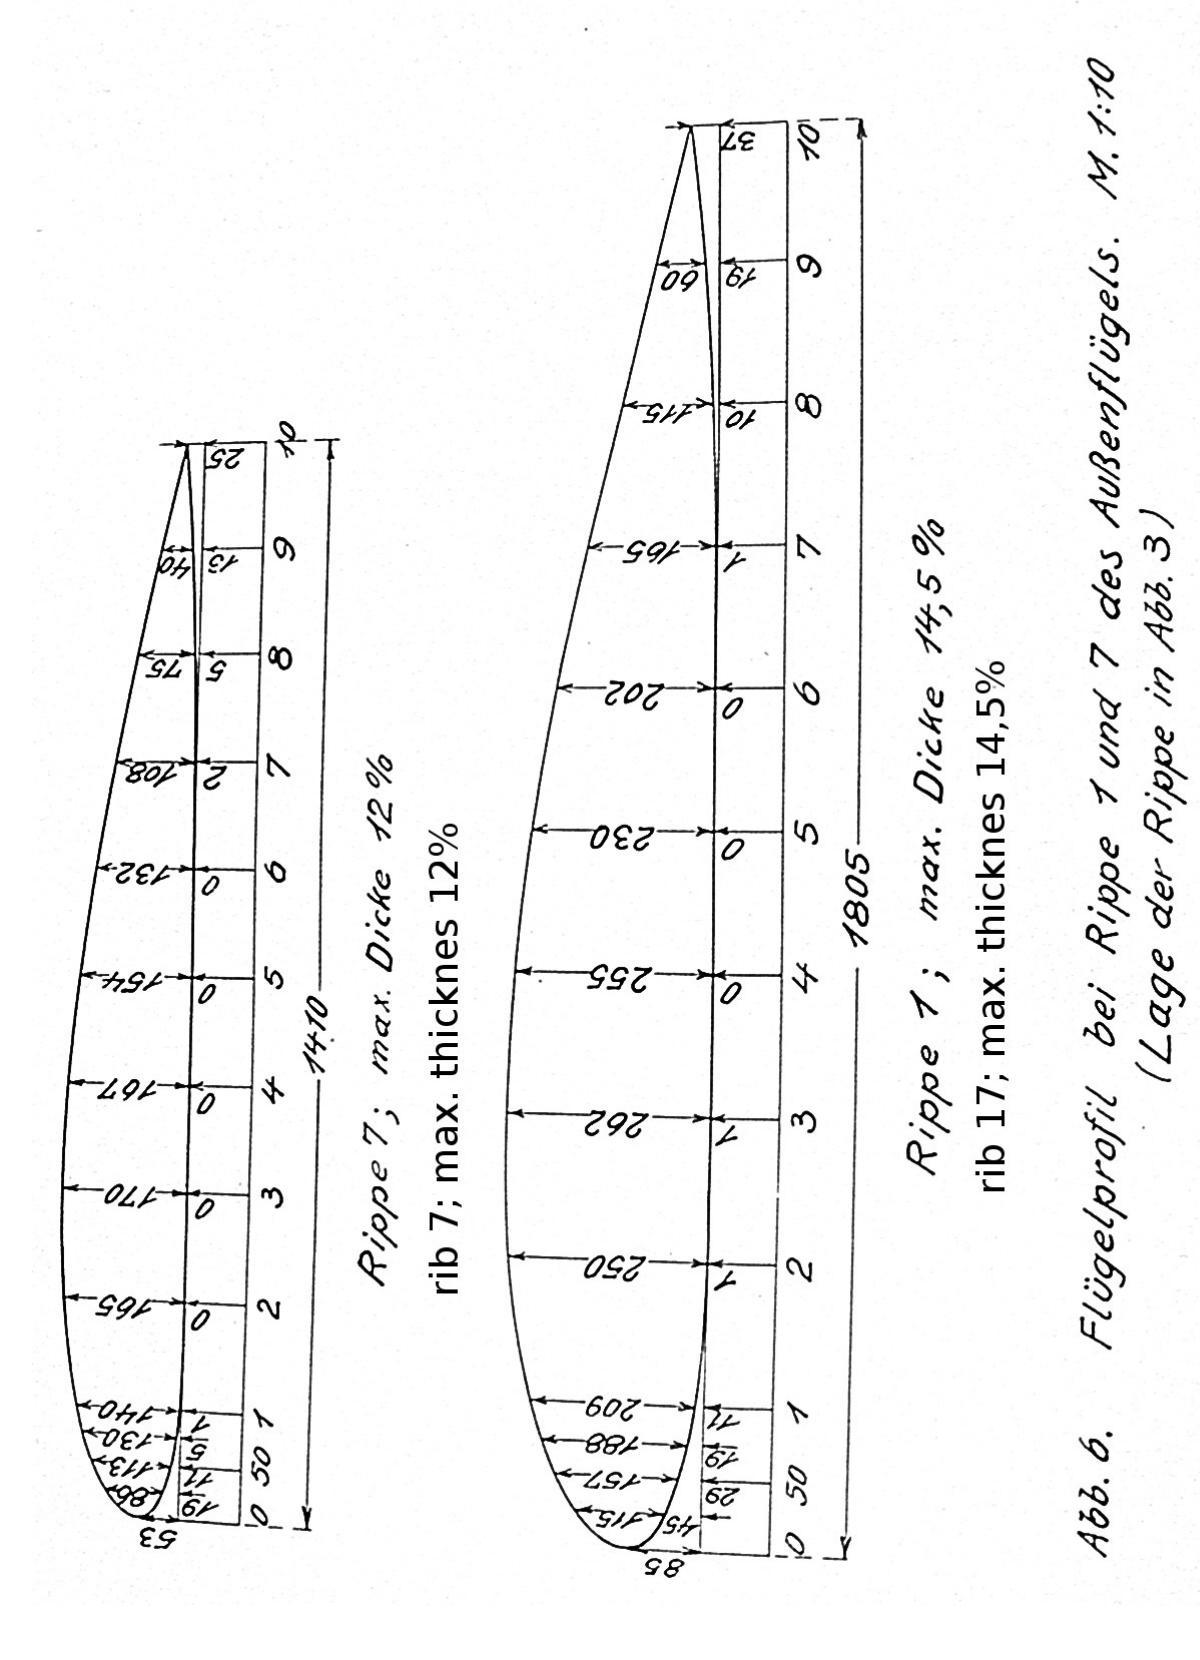
Wing profile at rib 1 and 7 of outer wing. scale 1:10 (position of rib in Pic.3) Pic. 6

To determine the centre of lift the wing profile was measured at two sections (pic.6)– root rib 1 and rib 7 – as the profile number or polars were not known initially. The thickness distribution, as well as the chord of those two profiles are quite close to the corresponding lines of the profile

NACA – CYH ⁺⁾, whose polares can be used for the wing at hand (pic.7). Differences are in the maximum thicknes; 11,7% for the NACA – profile, but 14,5% for rib 1 and 12% for rib 7. For $C_{a max}$ the centre of lift is located at s = 0,285 t from the leading edge.

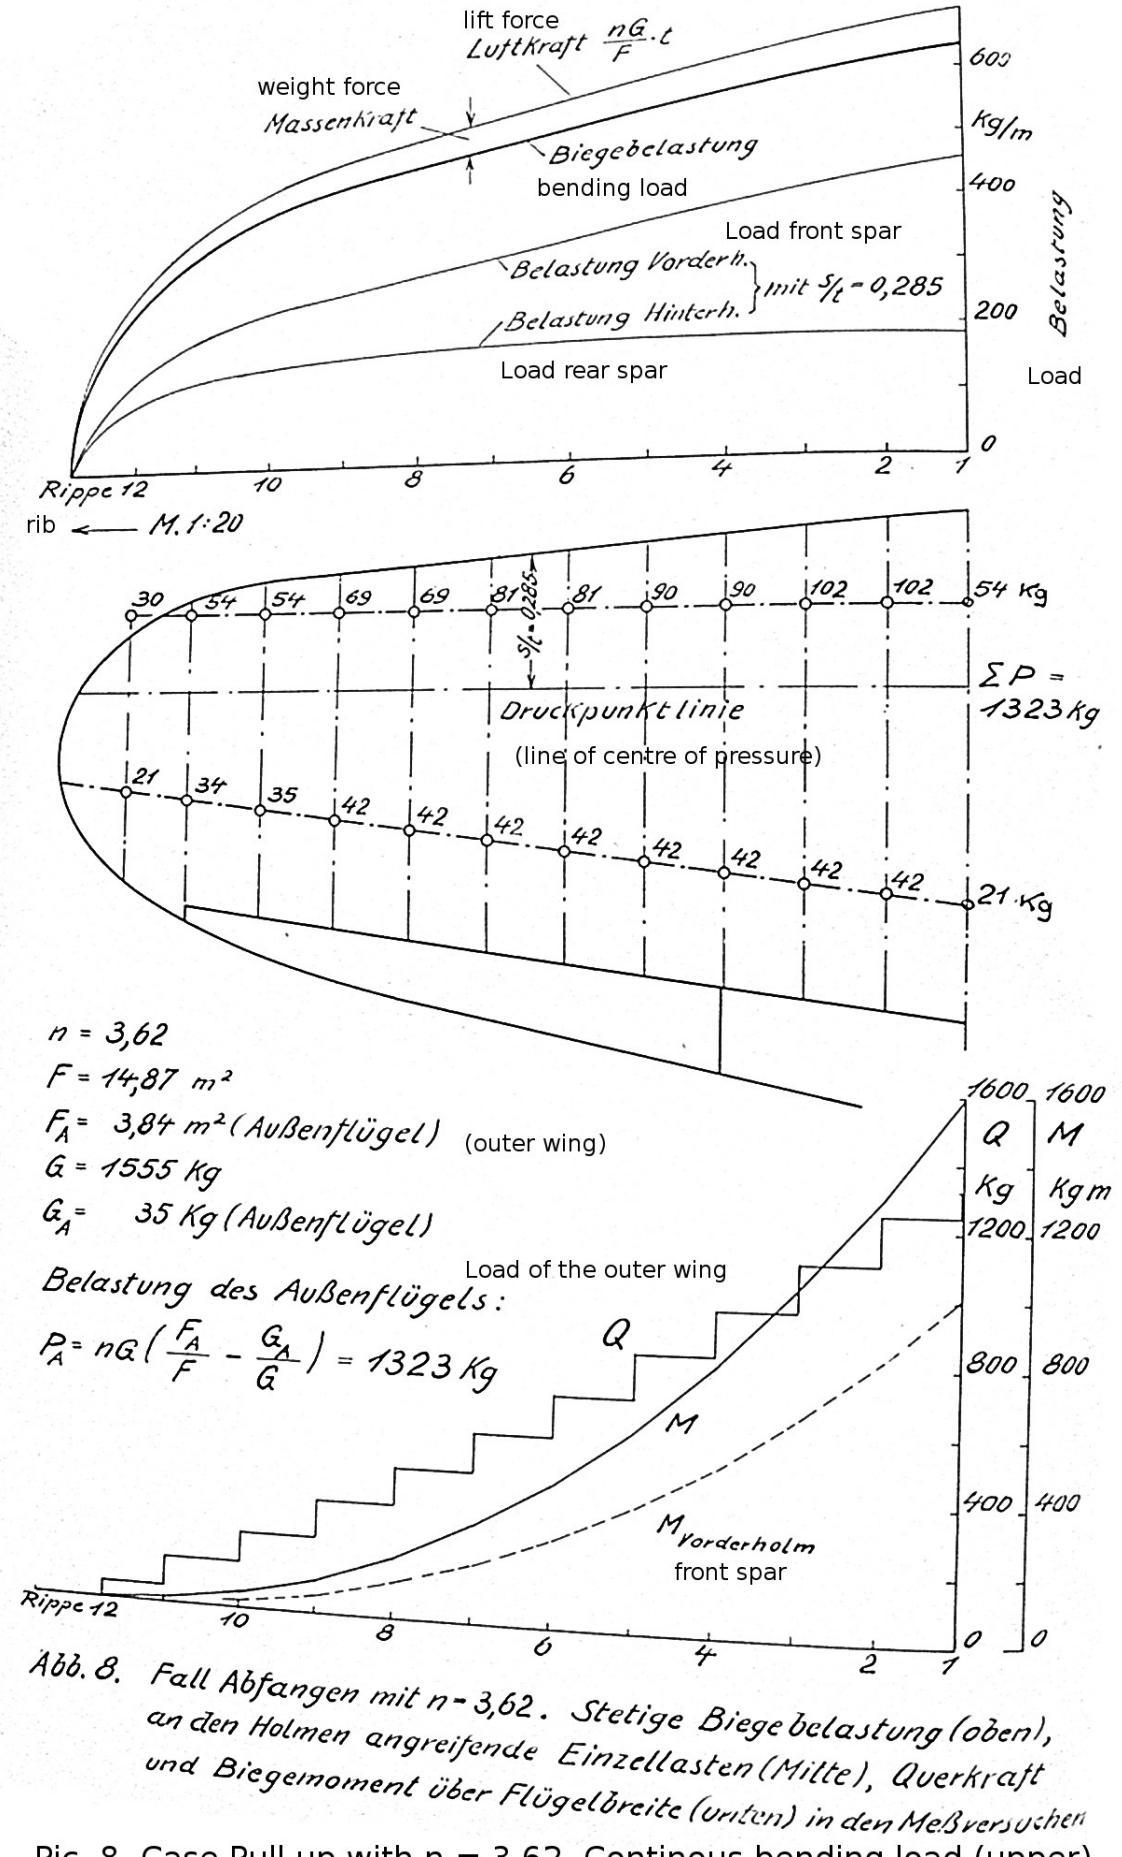
Pic. 8. Case Pull up with n = 3,62. Continous bending load (upper), point load at the spars (middle), shear force and bending moment over wing span (lower) in the measurement tests

For the test a load factor of n = 3,62 was used, i.e. About one third of the minimum required break load coefficient $n_A = 11,1$. Pic.8 shows the distribution of the lift and the residual weight force n * 35kg in spannwise direction. The resulting load was distributed according to the centre of lift position, while for simplifaction the load centre of the residual mass force was approximated at the centre of lift position (s/t = 0,285) too. Those continous spar loads were then broken into distinct loads at each rib position. Those point loads for the test, as well as the resulting shear loads and bending moments are also shown in Pic.8. At rib 12, which doesn't connect with the front spar, the point load is attached to an extension of the front spar (see Photo Pic.10).

with $n_{B(failure)} = 6,5$ to 7,5 and centre of pressure at 50% of chord – the spar cap stresses are smaller than in the first case throughout. For the test to destruction the load distribution was the same as in the measurement tests (Pic.8). The load was stepped up by n = 0,5 each time.

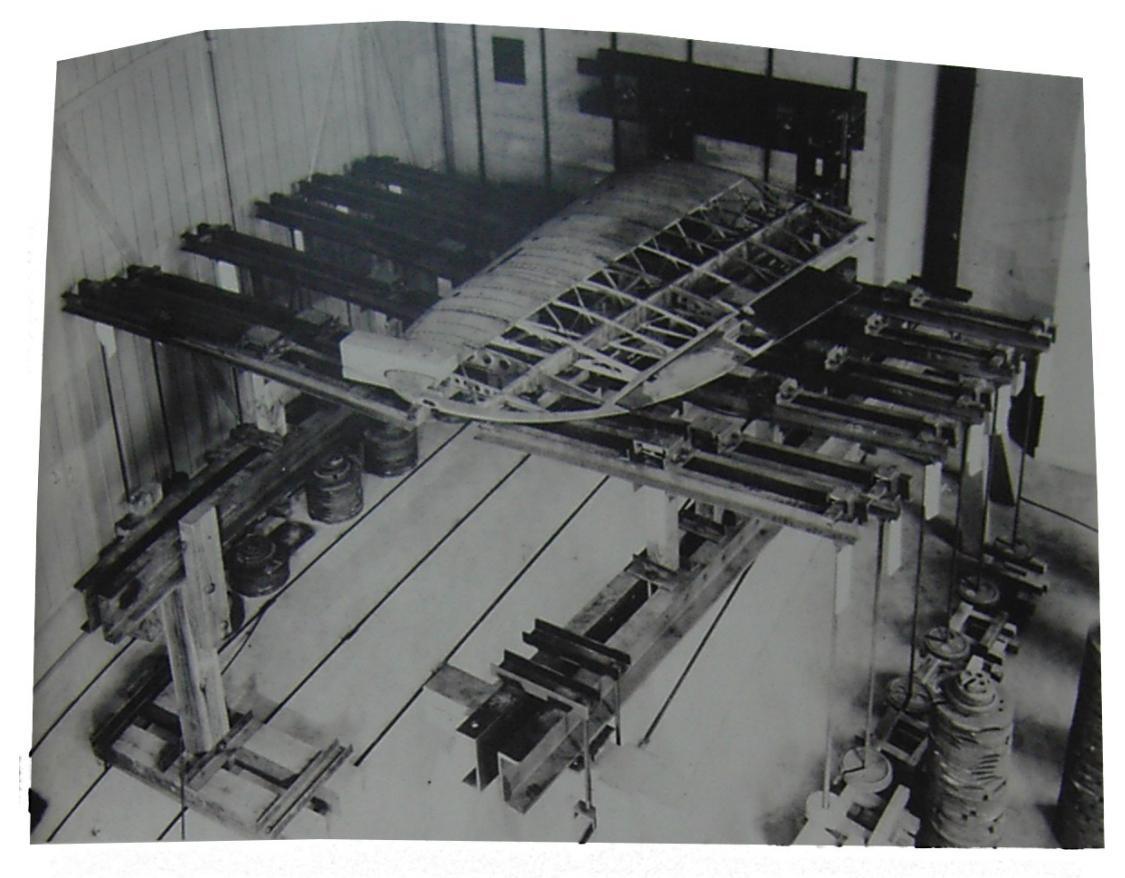
<u>Abb. 10</u> Versuchsanordnung. - Die an den Holmen angreifenden Einzellasten wurden über Umlenkhebel durch geeichte Plattengewichte eingeleitet.

The spar point loads (Pic.8 and 9) were applied exclusivly at the wing bottom. They were applied at each rip cap below the spar cap and were effected by calibrated plate weights via bellcranks (see testing apparatus in photo Pic.10). The loads on rib 1 from Pic. 8 and 9 were not applied.

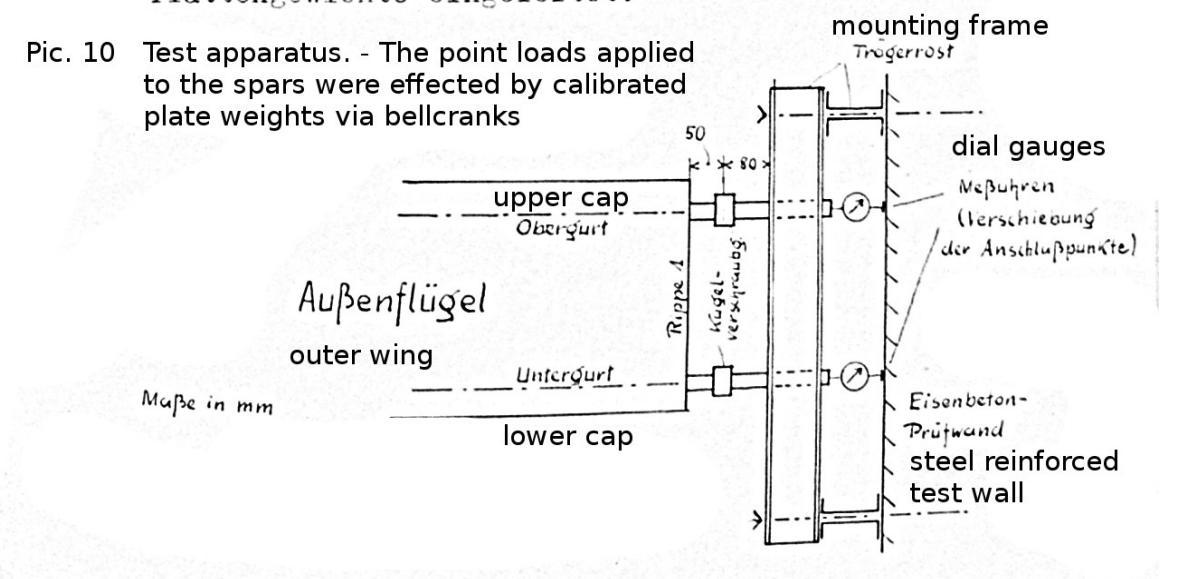
- Abb. 10a Schematische Darstellung des Flügelanschlusses. Die am Innenflügel sitzenden, nicht vorhandenen Teile der Hugelverschraubungen beider Holme wurden für den Versuch neu angefertigt und am Trägerrost steif befestigt.
- Pic. 10a Schematic view of the wing joint. The sperical contact joint parts, that are located at the inner wing and which were missing, were newly manufactured and rigidly mounted on the carrier frame.

The wing was connected to a vertical, considered rigid steel reinforced contrete testing wall, via a carrier frame. For this the sperical contact joint parts, that are located at the inner wing and which were missing, were newly manufactured and

rigidly mounted on the carrier frame (see Pic.10a). The wing was tensioned before the tests, that while testing no wire would be tensionless with certainty.

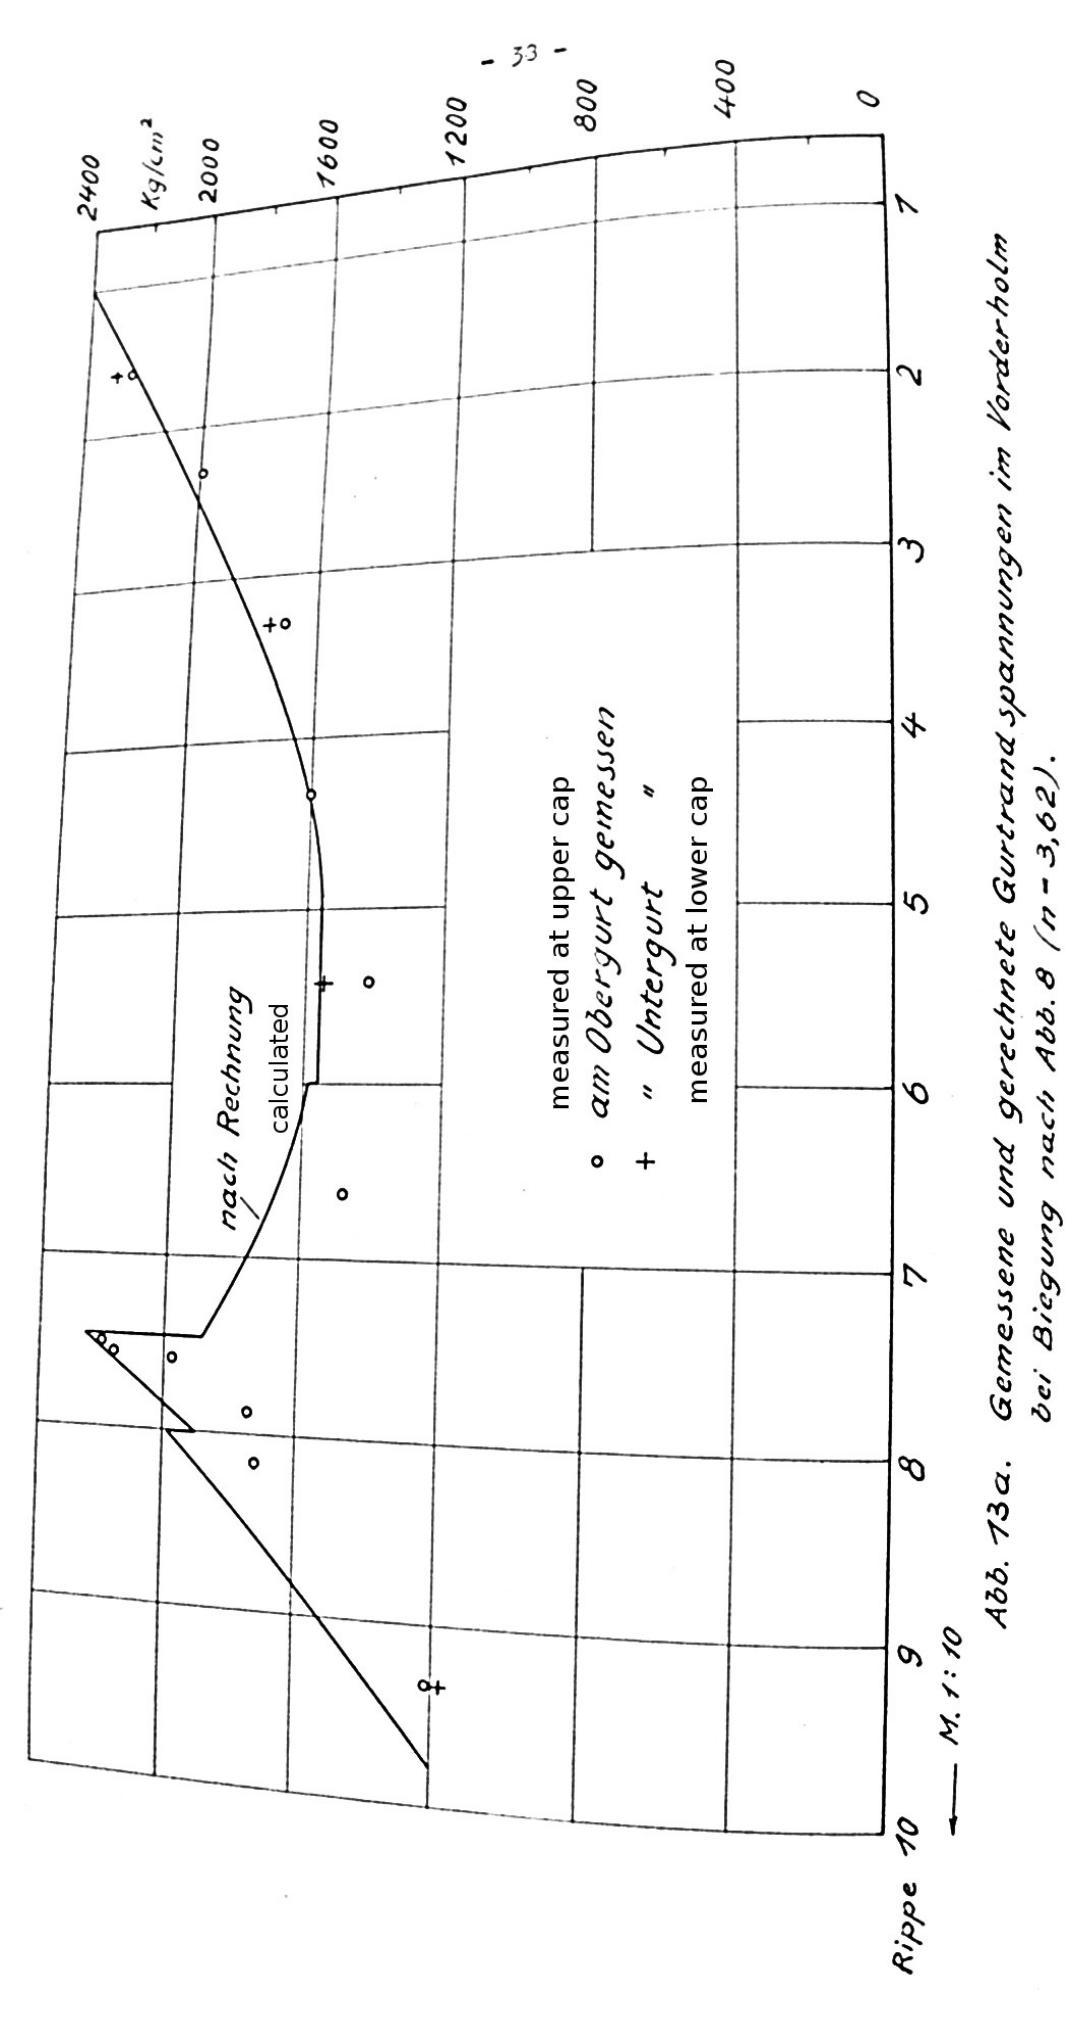
Measured and calculated outer fibre stresses in front spar under bending re. Pic. 8 (n = 3,62). Pic. 13a

In Pic.12 the measured stresses from the tension wires are compiled. Pic.13 a and b show the stresses in the cap extreme fibres of both spars. Here the calculated extreme fibre stress is shown for comparisson, which is set on the assumptions, that only the spars are working, that there is no combound effect in between the spars and that the stress distribution in the spar is linear. The first two assumptions are met at least for the present load case in a practically exact way (see the results of the bending deflection tests further down), the second is confirmed by sufficiently many single tests, in which the cap stresses were established in several surface lines of one cross section (see for example Pic.11 and 14). In between the results of the calculation and the measurement in Pic.13 a and b practically certain agreement is given.

Important assessment, that based on the measured cap stresses at n = 3,62 (Pic.13a and b) the material yield strength was reached at some positions at n = 18. Even when recognising a certain stress equalisation in the post elastic range, therefore the ultimate (break) load factor can not be much higher than n = 18.

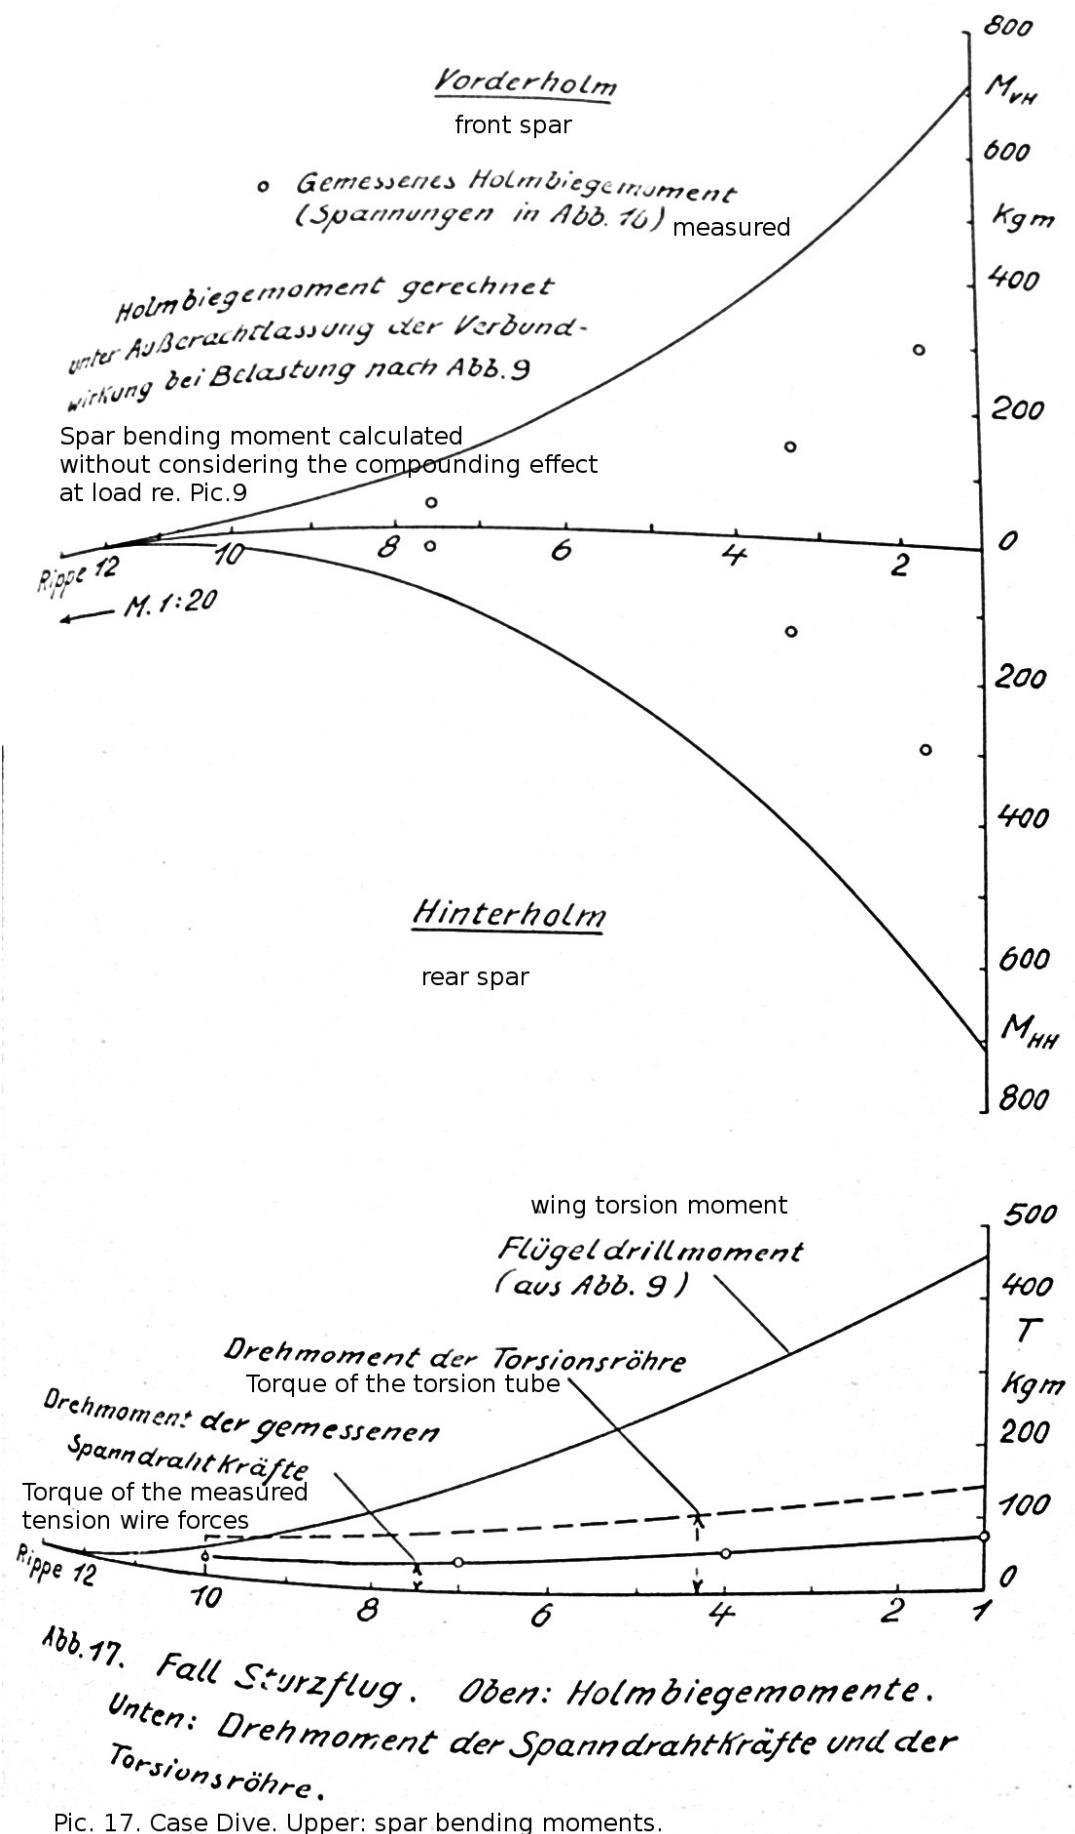
Lower: torsion moments of the tension wire forces and of the torsion tube.

The evaluation of the test results (Pic.17) shows in rough approximation, that in average 40% of the torque is taken by the spars via shear bending and 60% is taken as shear by the torsion tube created by the spars and tension wires. Pic.17 shows at the top the bending moments, equal by absolute value, that result, when the compound effect under load as per Pic.9, centre, is neglected, and at three positions the spar bending moments that are calculated from the spar cap tension stresses from Pic.16. In the lower illustration of Pic.17 the wing torsion moment (from Pic.9 lower) and the torsion from the measured stresses (Pic.16) from the tension wire forces is compared; the torque of the torsion tube is in average double the magnitude. - A small (not established in numbers) part of the torque is absorbed by the torsionally rigid spars themselfs.

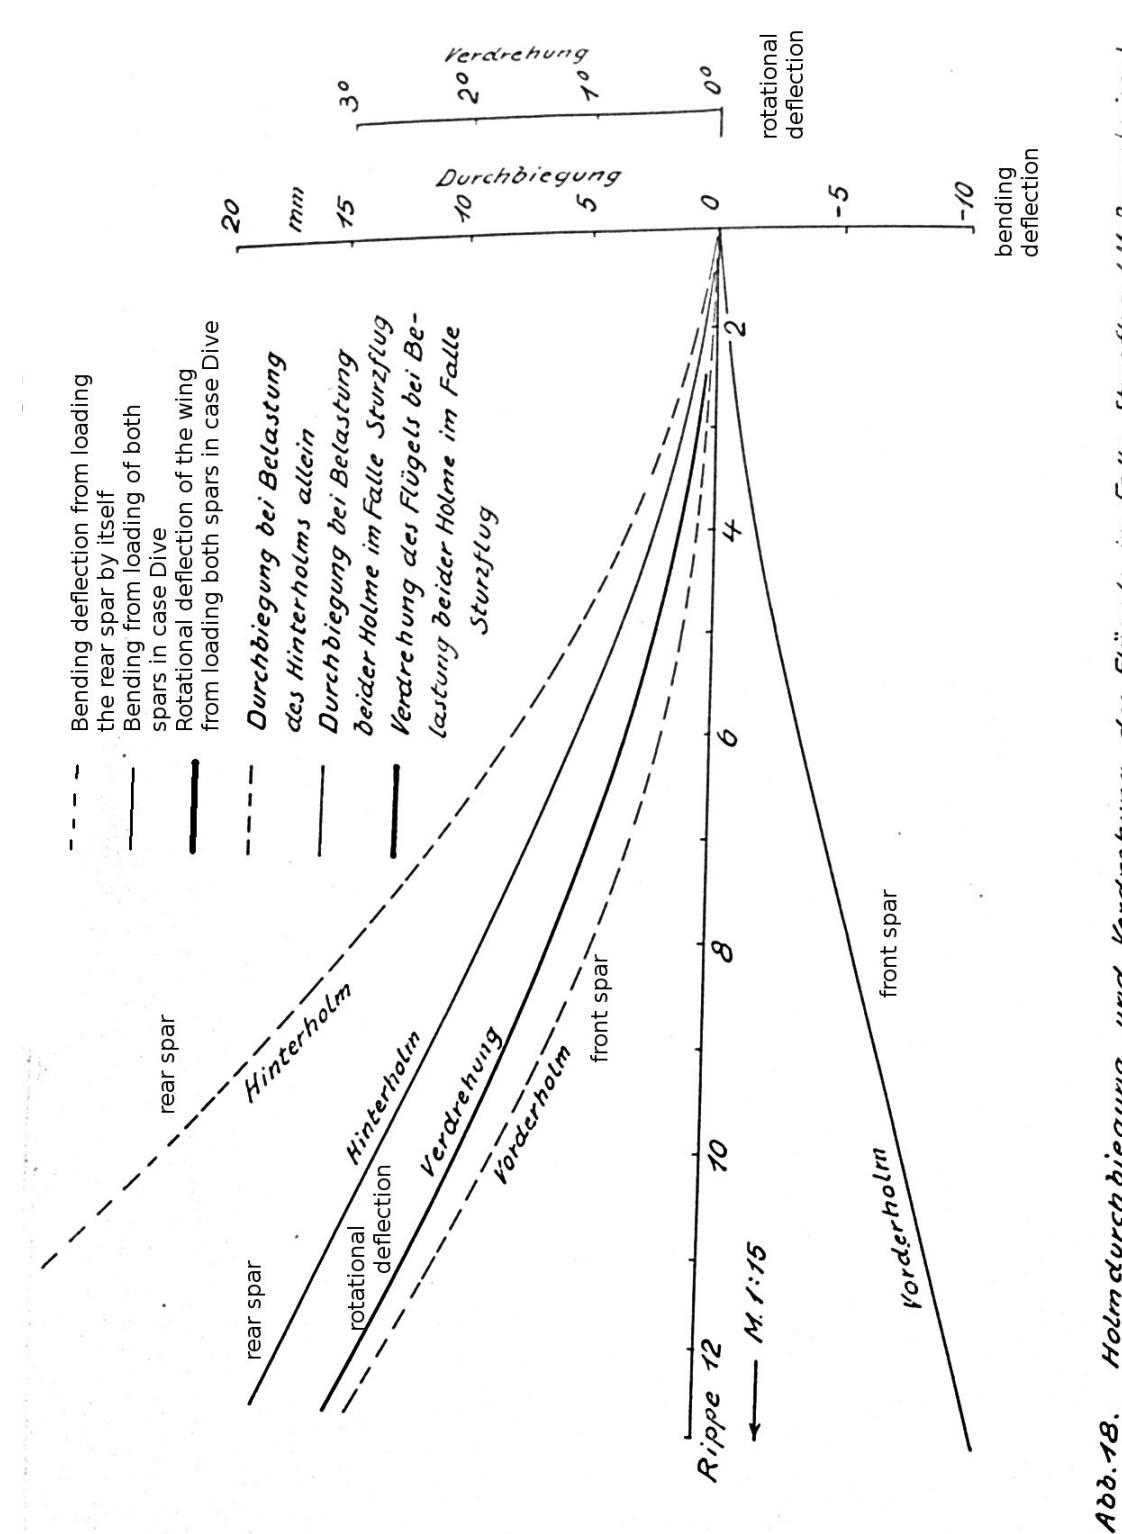
Spar bending deflection with loading of the rear spar by itself. The rotation of the spar that is effected by the soft mounting structure is eliminated. Spar bending and rotational deflection of the wing in the case Dive (measurement results) Pic. 18.

Pic.18 shows the bending curves of the spars and the twist of the wing in the case 'Dive'. To give a magnitude for the compound reaction, the bending curves for both spars are drawn in as well, for when only the rear spar is loaded. Here, too, as in the bending case, the rotation of the spars, affected by the softnes of the mounting structure, is eliminated.

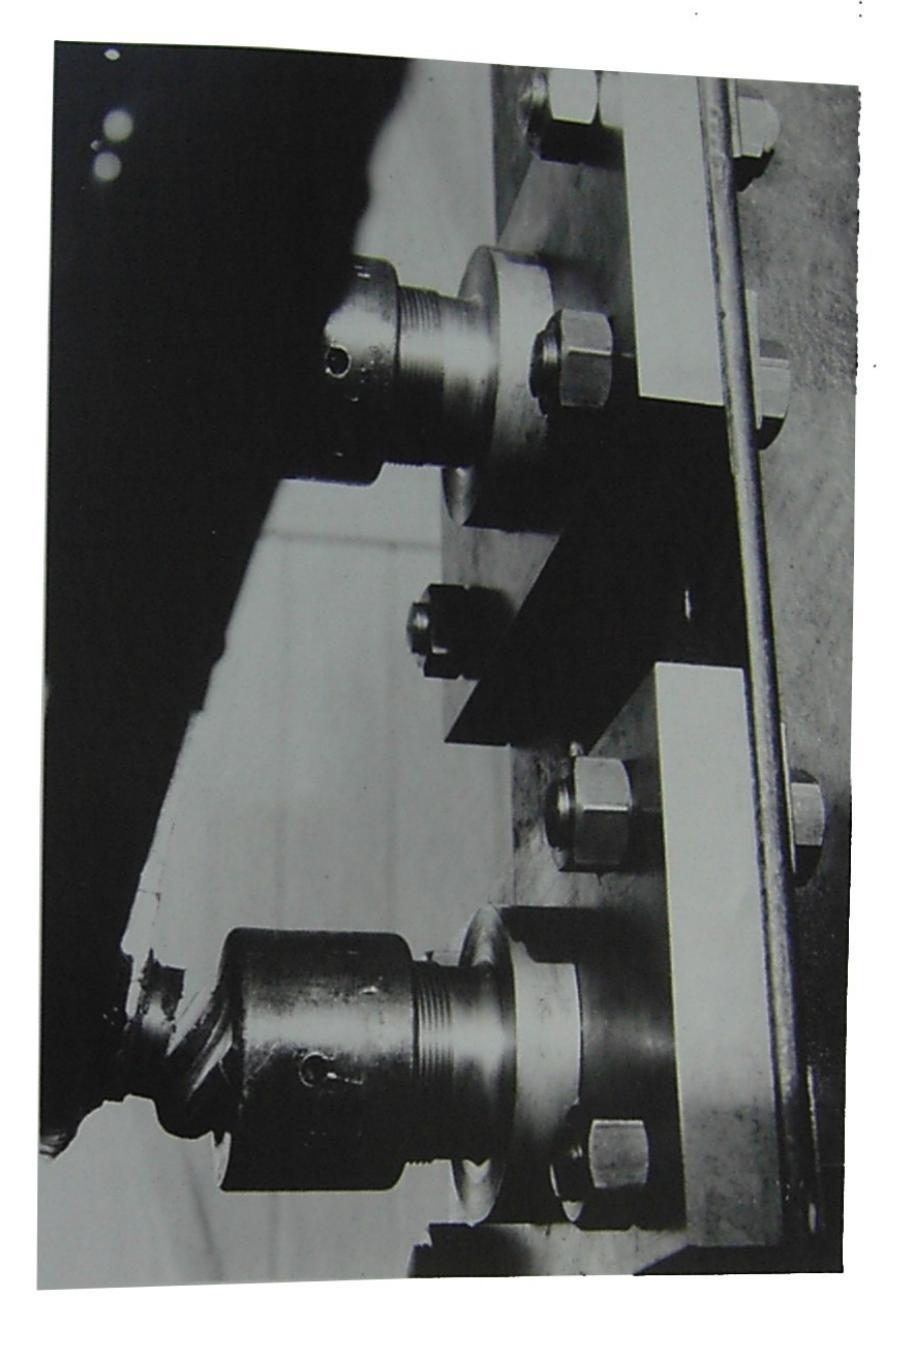
joint of upper cap

joint of lower cap

- Abb. 19 E.uch am Untergurtangehluß dis Vorderholms etwas oberhalb des Lastvielfachen n = 16,5. Nach dem hiß im Ifannenhals wurde die Rugelpfanne aus der Oberwurfmutter herausgezogen.
- Pic. 19 Failure of the joint of the lower spar cap of the front spar just above the load factor n = 16,5. The neck of the ball socket was ruptured on top, the ball socket almost completely pulled out of the retainer nut.

In the third and last Test a load factor of n = 16,5 was held without failure. While load increase to n = 17,0 the joint of the lower cap of the front spar broke (photo Pic.19): The neck of the ball socket was ruptured on top, the ball socket almost completely pulled out of the retainer nut. Photo Pic.20 shows the joint disassembled from the wing.

The premature failure in comparison to the held load factor of the first test (n = 18) indicates, that the joint was already strained in the first test. Assuming that the established load

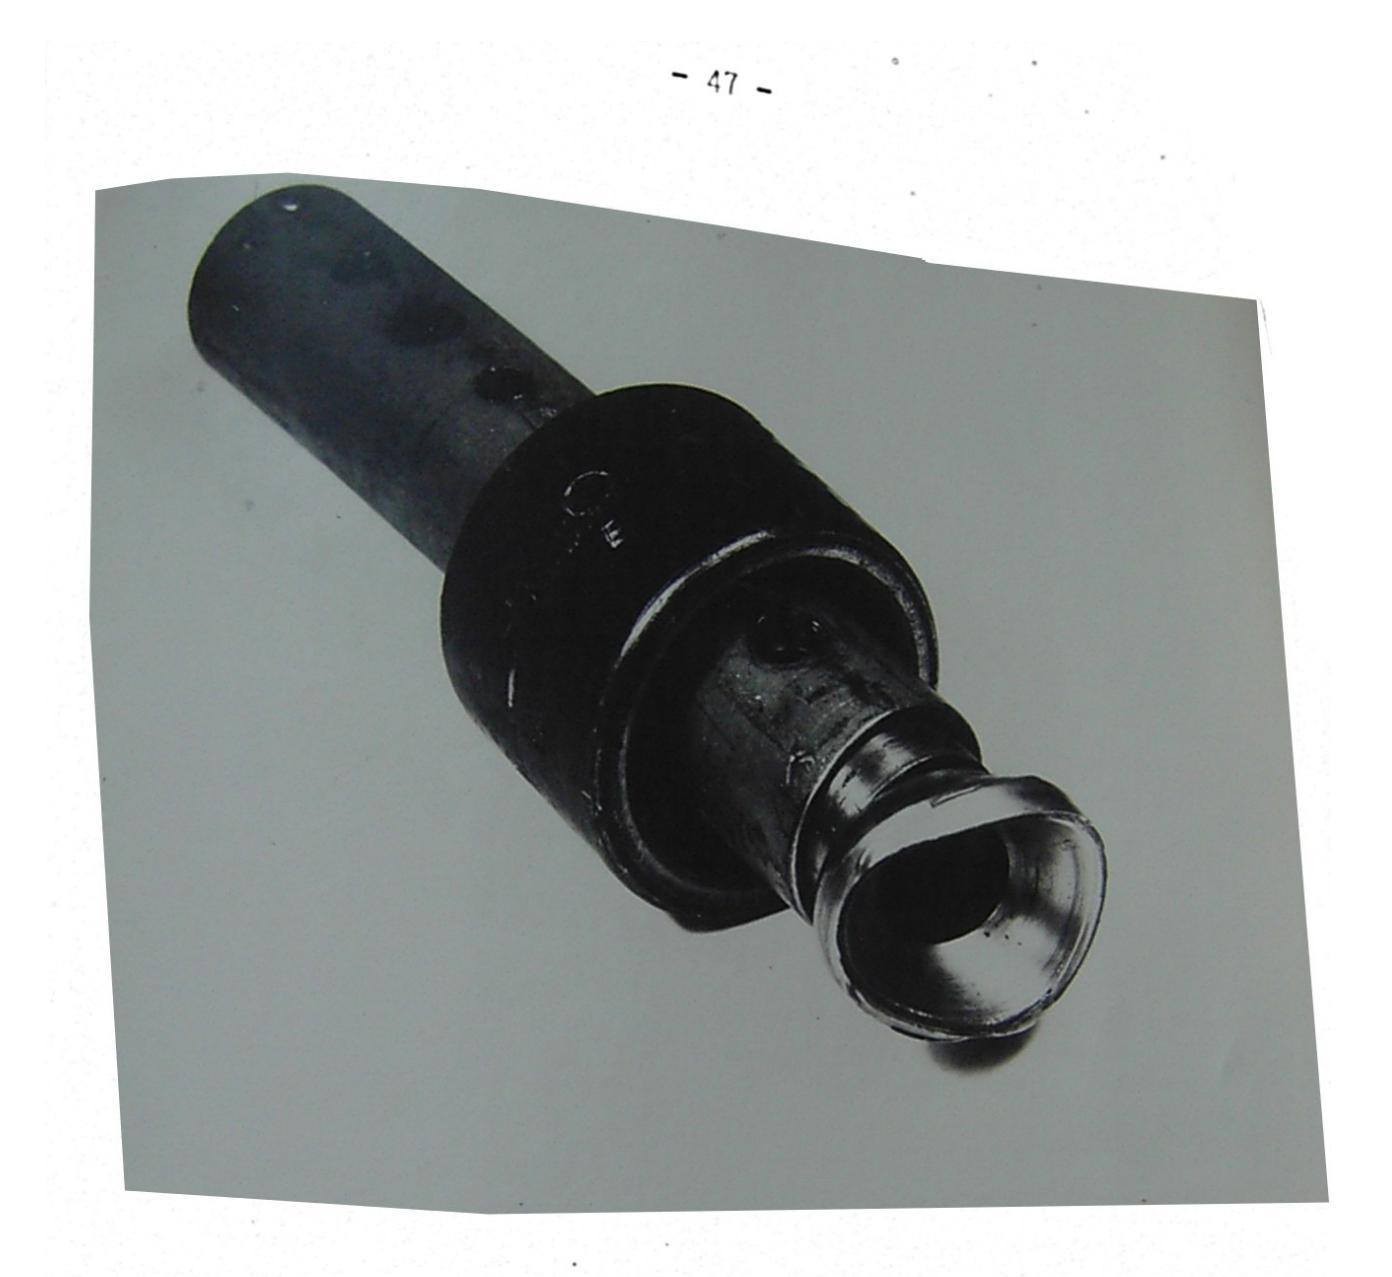
- <u>Abb. 20</u> Der nach dem Bruchversuch vom Außenflügel gelöste Untergurtanschluß des Vorderholms.
- Pic. 20 The disassembled joint of the lower spar cap of the front spar after the test to destruction.

distribution of the wing bending moment at the load factor n = 3,62 does not change at higher loading, then the bending moment for n = 18 at rib 1 in the front spar computes to (Pic.8) $M_1 =$ 1013 kgm* 18/3,62 = 5030 kgm and the connection forces $M_1/h_1 = \pm 5030/0,18$ kg = ± 28000 kg (spar distance h_1 out of Pic.4a). For a cross section of the neck of the ball socket of 2,7 cm²⁺⁾ the stresses compute to ± 10360 kg/cm² for uniform stress distribution. Furthermore stresses are introduced due to bending of the neck of the ball socket, for upwards directed load tensile stresses on the top side and compressive stresses at the lower side of each joint. The failure happend on the side of the highest tensile stresses, i.e. On the top side of the lower joint. After rupture the ball socket was not loaded axial symmetrically anymore, but only along part of its circumference, which lead to the visible deformation in Photo Pic.20.
