Deutsche Luftfahrtforschung

Examinations and Notices No. 562

Report about strength examinations on an outer wing of the russian airplane type Rata I16 Krumbholz

drafted by Deutsche Versuchsanstalt für Luftfahrt E.V. Institut für Festigkeit Berlin-Adlershof

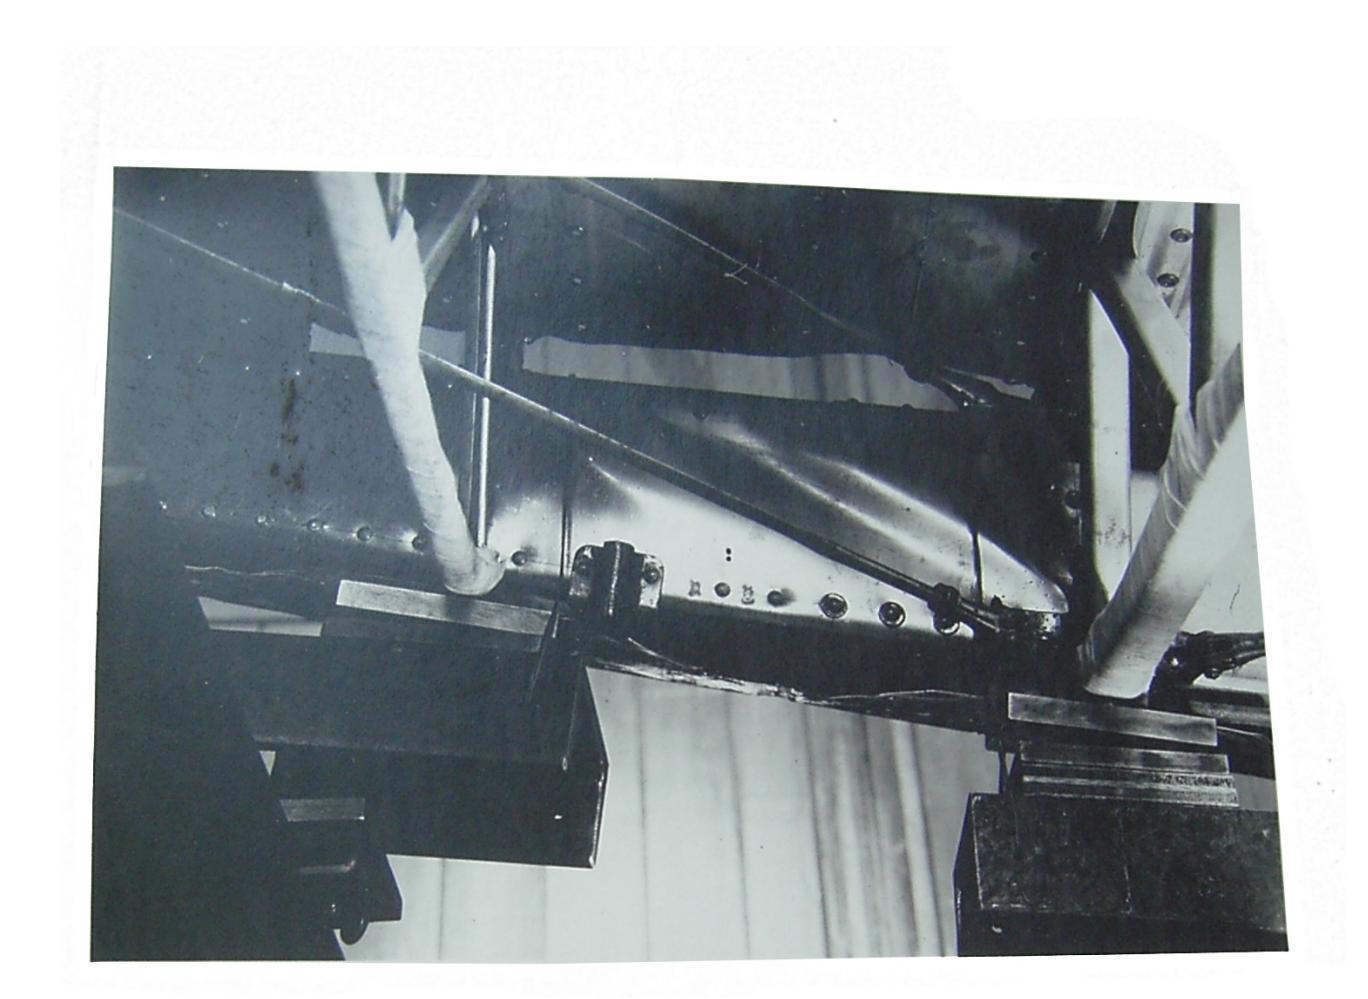
- Abb. 21 Charakteristische Zuglalte im Stegblech des Vorderholms zwischen den Rippen 7 und 8. Die Aufnahme wurde nach dem Bruch des Anschlusses (Abb.19) gemacht, als der Holm z.T. schon entlastet war.
- Pic. 21 Characteristic tension wrinkle in the web skin of the front spar in between rib 7 and 8. The picture was taken after the failure of the joint (pic.19), when the spar was already partially reliefed.

From a load factor of n = 6 tension wrinkles started to develop in the web skin of both spars. Those were first only recognizable in the front spar outboard from rib 6, in the rear spar outboard from rib 3, but developed until load factor n = 9 over the whole length of the spars. The wing held, without showing any further anomalies, the load factor n = 18 for more than one minute without failure. As no higher load was anticipated for the testing rig, the test was terminated. The tension wrinkles in the spar webs remained after load relief, the ones in the front spar close to the wing joint and in both wings close to the cap joints especially pronounced.

In photo Pic.21 an especially strongly formed, characteristic tension wrinkle in the web skin of the front spar in between ribs 7 and 8 is shown. When taking the photo, which was taken immediatly after the failure of the joint, the front spar was already partially reliefed.
